**AFRL-RX-WP-TP-2009-4053**

**TENSILE CREEP AND FATIGUE OF SYLRAMIC-iBN  
MELT-INFILTRATED SiC MATRIX COMPOSITES :  
RETAINED PROPERTIES, DAMAGE DEVELOPMENT,  
AND FAILURE MECHANISMS (PREPRINT)**

# **Tensile Creep and Fatigue of Sylramic-iBN Melt-Infiltrated SiC Matrix Composites: Retained Properties, Damage Development, and Failure Mechanisms**

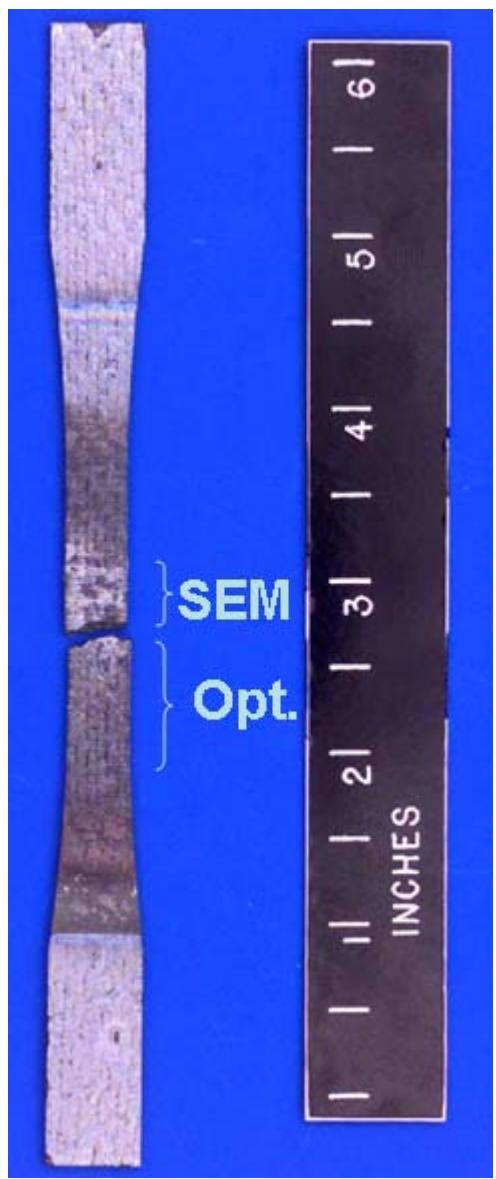
Figure 1: Typical failed specimen after creep or fatigue.

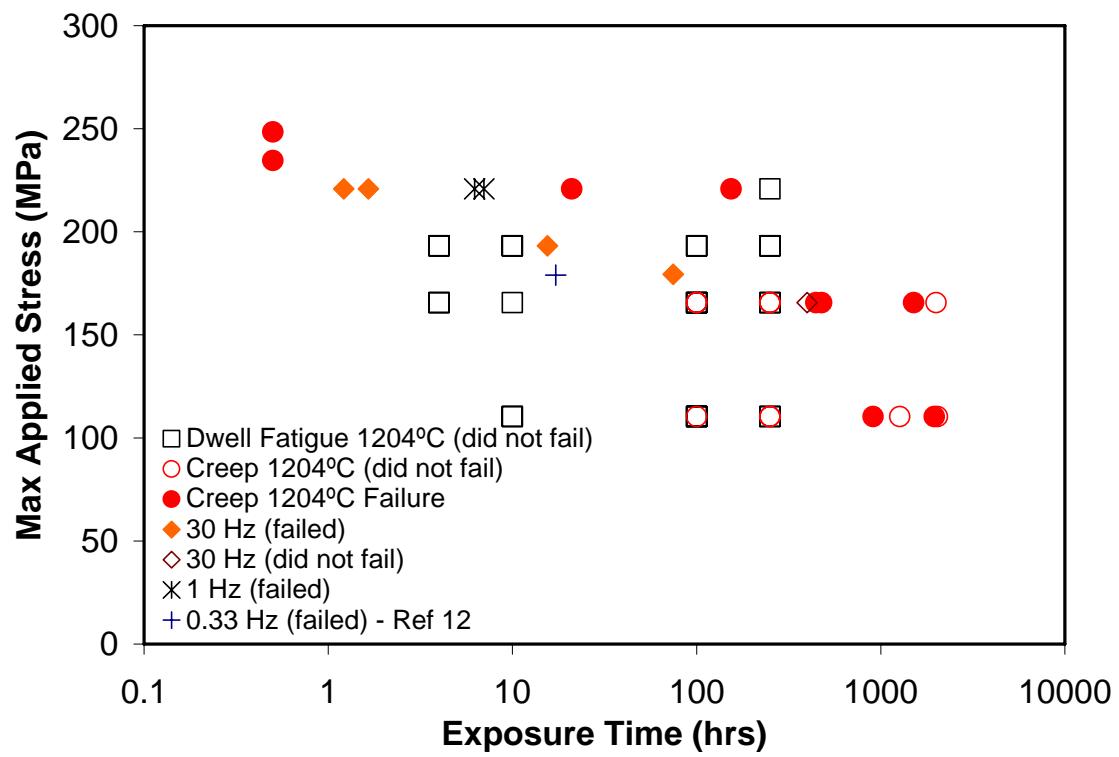
Figure 2: Creep and fatigue data versus time for the different elevated temperature tests.

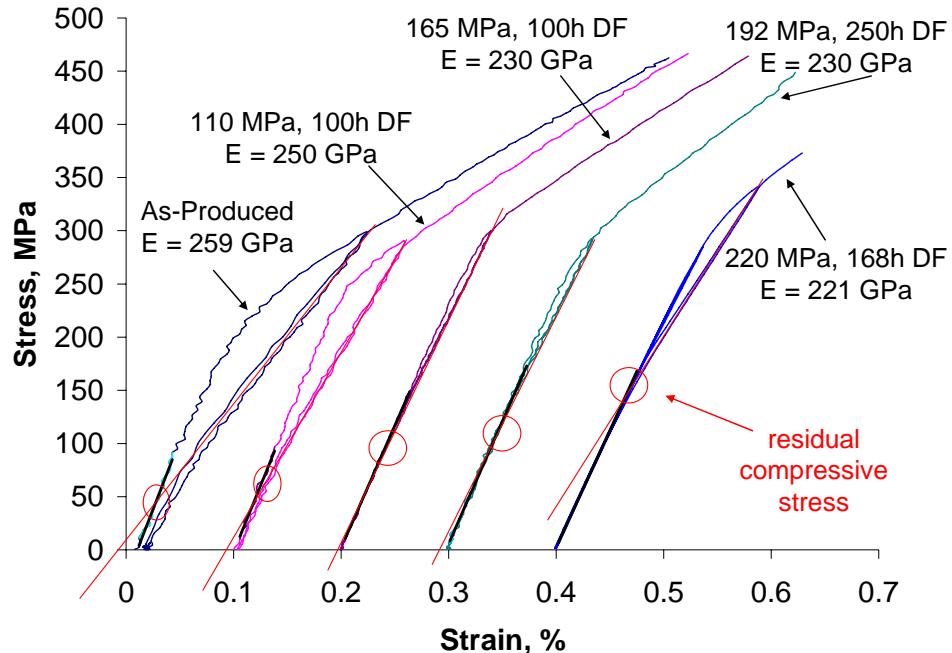
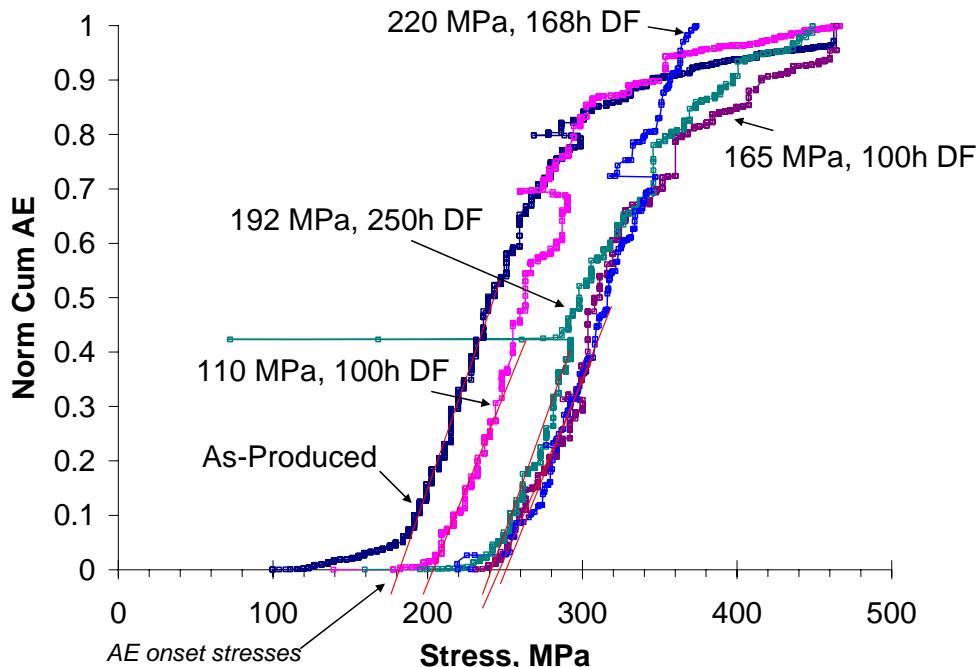
Figure 3: Room temperature stress strain behavior (a) and AE behavior (b) for an as-produced and two after-creep specimens. Note that the stress-strain curves in (a) are offset for clarity.

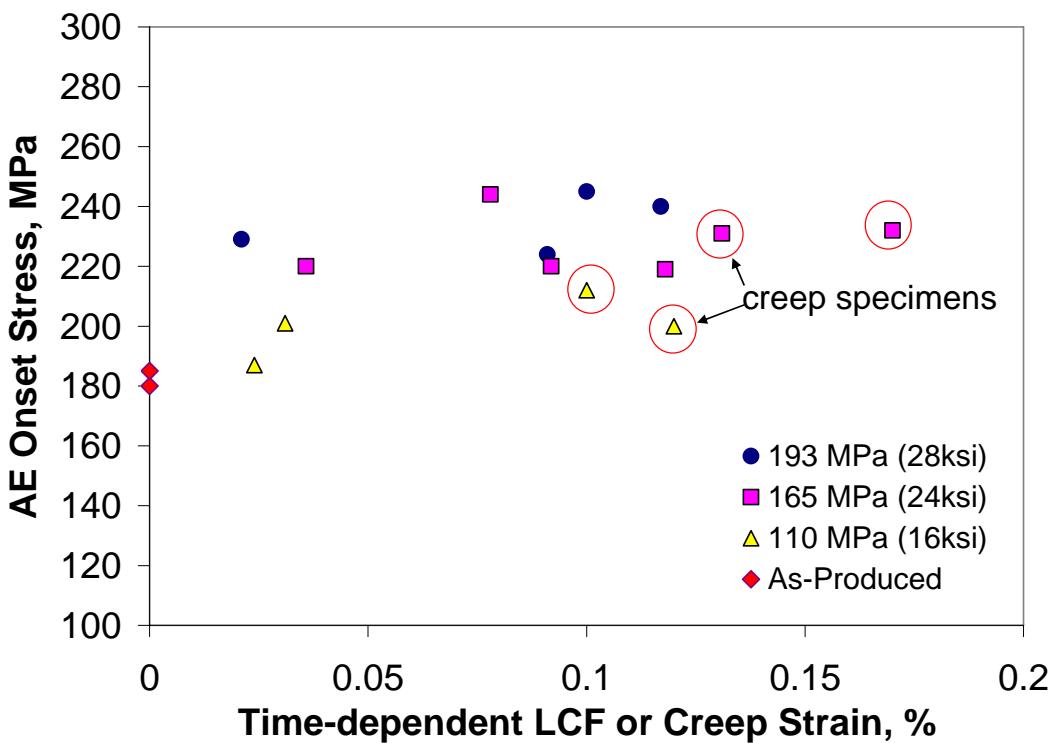
Figure 4: Room temperature AE onset stress vs time dependent strain for DF and creep (where noted) tests.

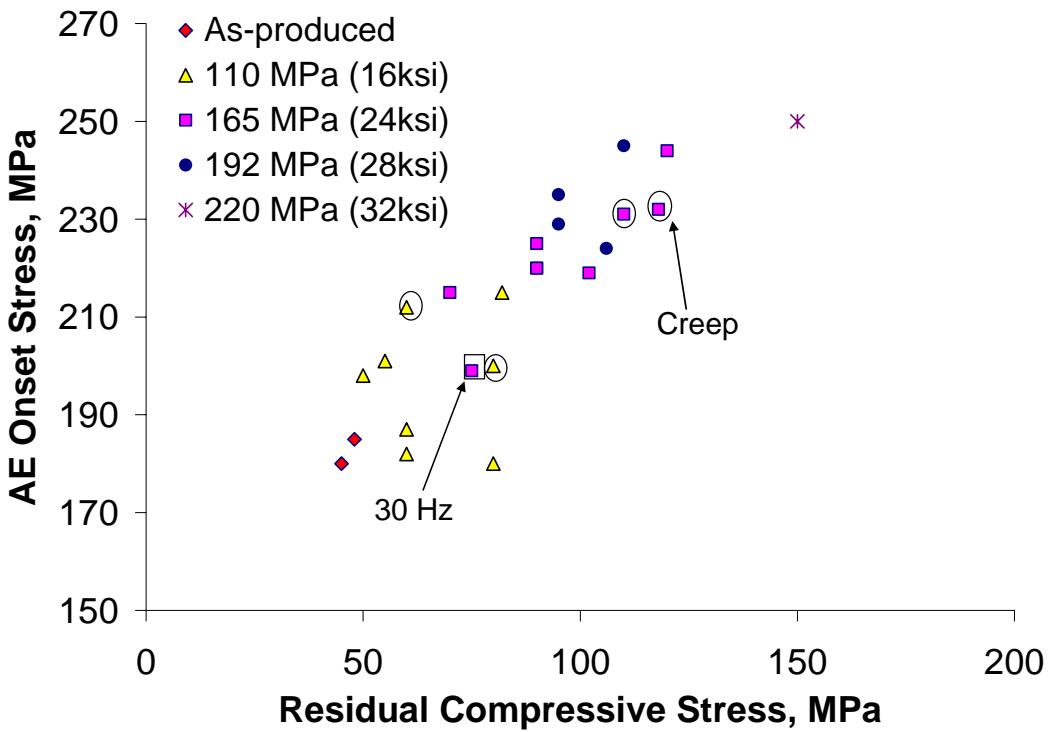
Figure 5: Matrix cracking stress as determined from AE versus the residual compressive stress in the matrix. Most of the data is for DF tests except where noted.

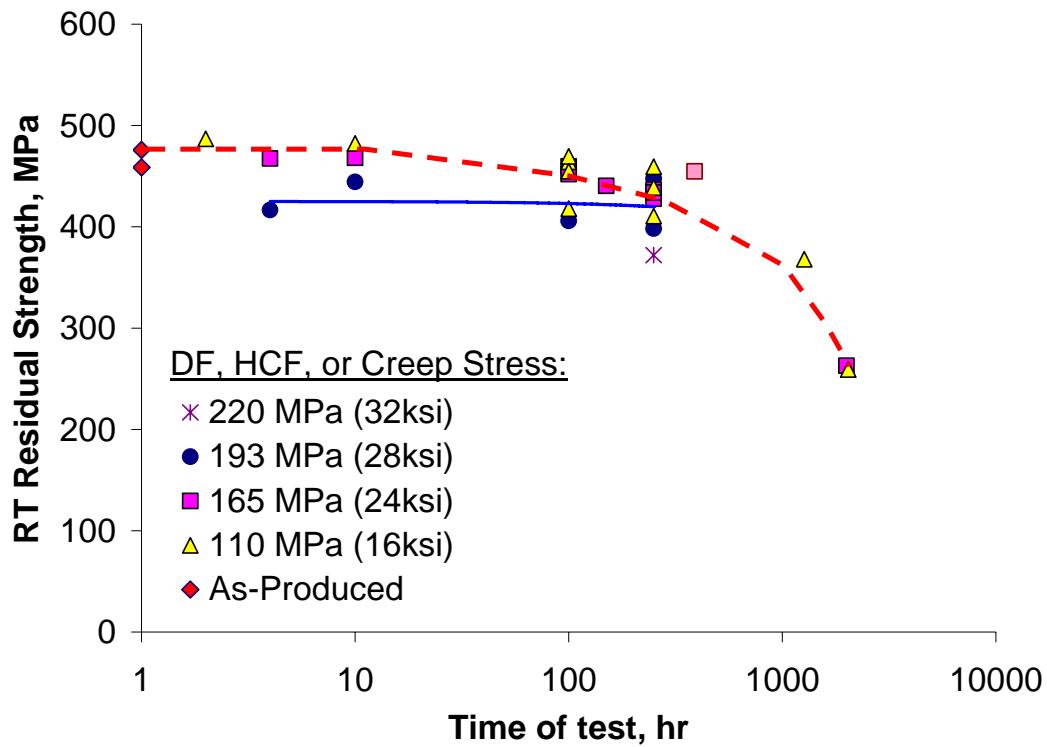
The ultimate properties are shown in Figure 6 for the different specimens. Note that for applied creep/fatigue stresses of 165 MPa or lower, there is very little if any degradation in ultimate strength, even for specimens subjected to nearly 250 hours. There appears to be a 10% drop in strength of specimens tested at 193 MPa up to 250 hours and about a 20% drop for specimens tested at 220 MPa for 250 hours. Specimens that survived greater than 1000 hours at lower stresses showed greater degradation in room temperature ultimate strength. The room temperature strength of the specimen that survived 1239 hours at 110 MPa was degraded about 20% compared to as-produced

Figure 6: Ultimate strength at room temperature for as-produced and after creep or fatigue.

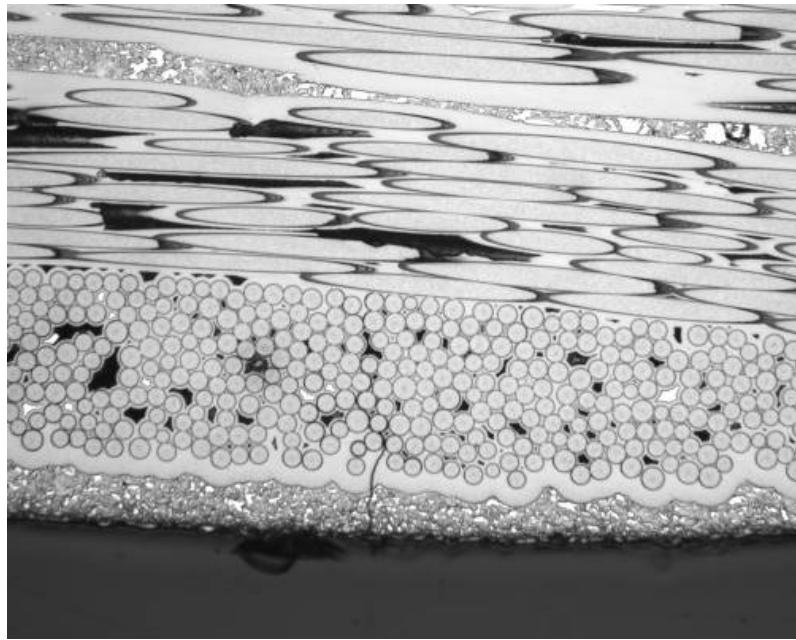
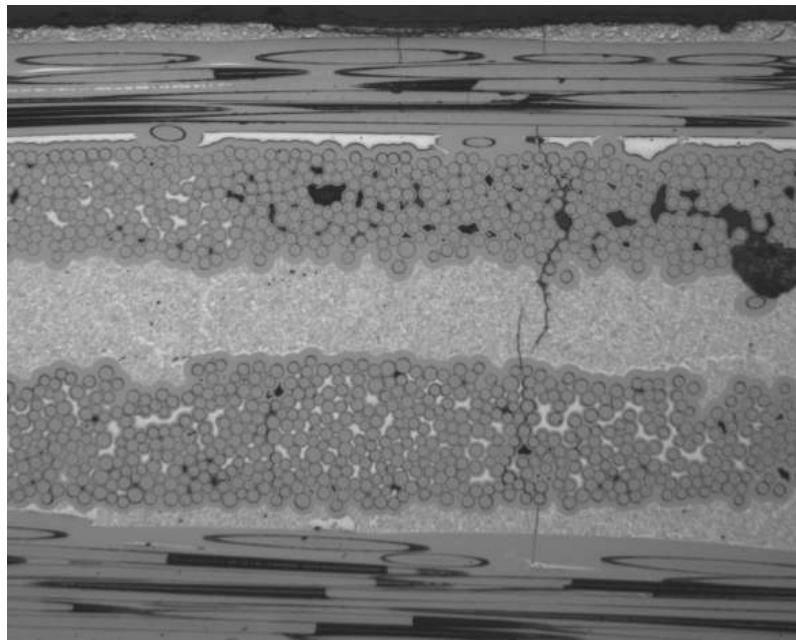
For edge aligned specimens, no cracks were observed for the specimens subjected to 110 MPa. For 165 MPa applied stresses and above, surface 90° minicomposite micro cracks (Figure 7a) and inner back-to-back 90° minicomposite cracks were evident for stress-temperature conditions up to 250 hours (Figure 8b). For 193 MPa applied stresses and above, cracks which penetrated up to two plies in from the face were common (Figure 7b). With increasing time and stress, unbridged cracks were observed along the length for 165 MPa and greater applied stress conditions (Figure 8). However, even for the specimens subjected to the highest stresses (220 MPa), these unbridged surface cracks typically extended only two plies and sometimes three into the thickness of the specimen. The presence of unbridged regions of cracks filled with a glass indicates that the fibers had failed at some significant period of time prior to ultimate failure of the composite.

Figure 7: Typical creep-formed cracks: (a) surface 90° minicomposite (110 MPa, 2036 hours, did not fail in rupture) and (b) inner back-to-back 90° minicomposite cracks which extended to the surface through a 0° minicomposite (165 MPa; 1508 hr creep rupture).

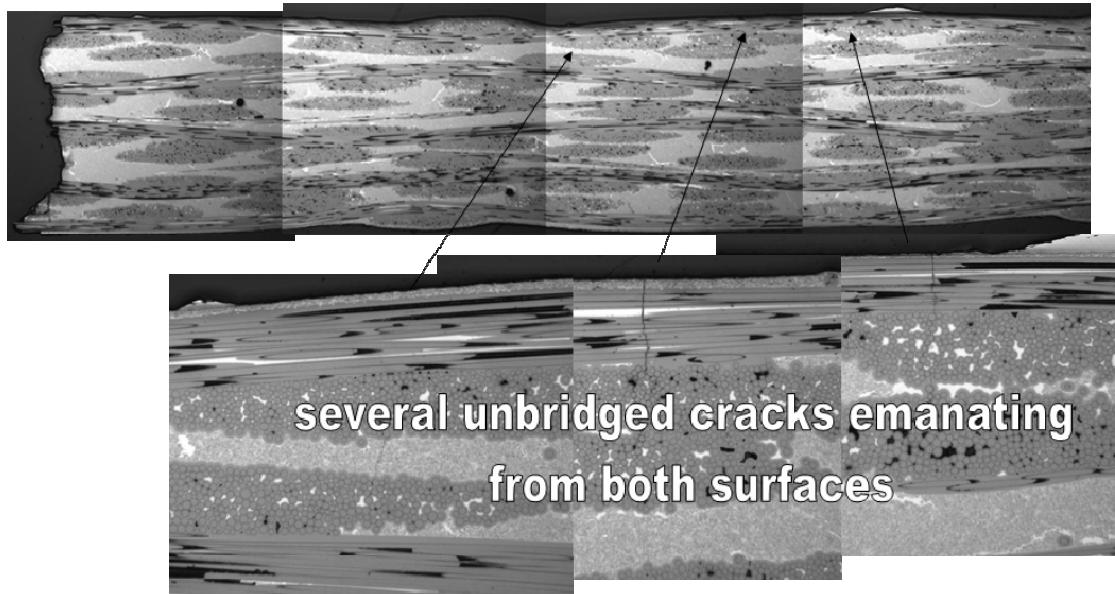
Figure 8: Matrix cracks that extend at least two plies from the surface and in some cases have fractured fibers in the matrix crack wake. This specimen had undergone 220 MPa 30 Hz fatigue and lasted approximately 1.2 hours at 1200C.

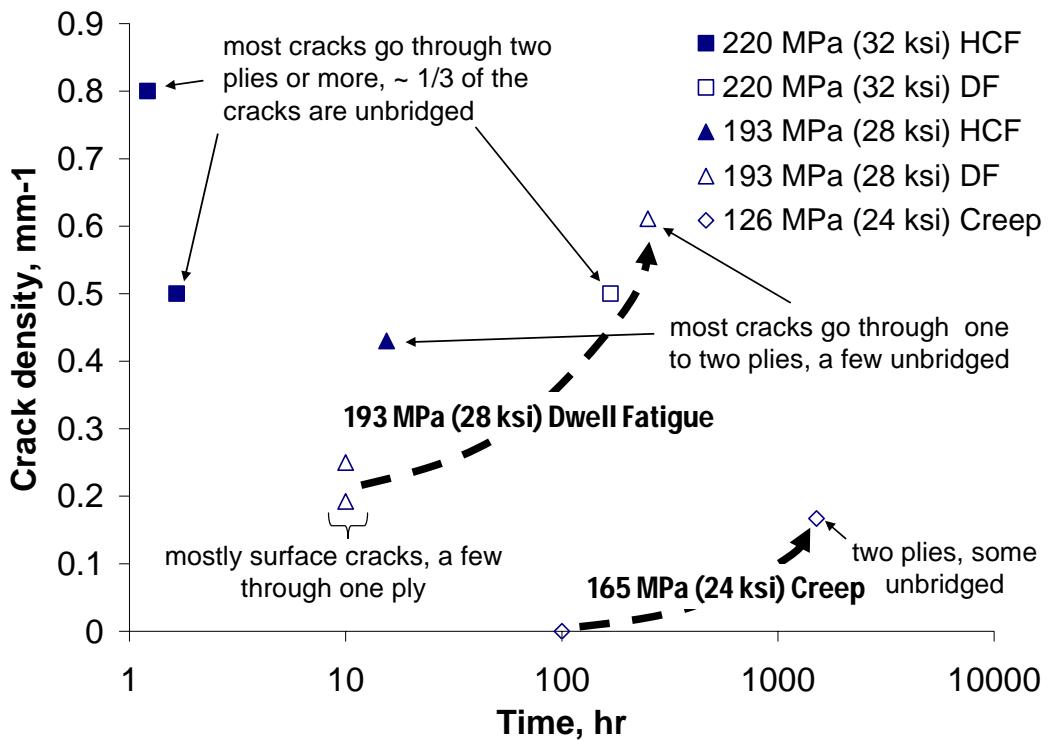
In order to quantify matrix cracking, the crack density, number of cracks per mm, and the depth of cracks were recorded and are plotted in Figure 9. It is evident that with increasing stress and time that the number of cracks increases and the depth of the matrix cracks increase. However, for most cracks, even for specimens tested at 220 MPa, very few appear to propagate through the thickness of the specimen. When polished along the face of the specimen so that cracks can be observed along the 8.2 mm width, matrix cracks rarely appear to traverse the width either for the 220 MPa stress-condition experiments.

Figure 9: Crack density along the length of the specimen for different stress, time, and loading conditions.

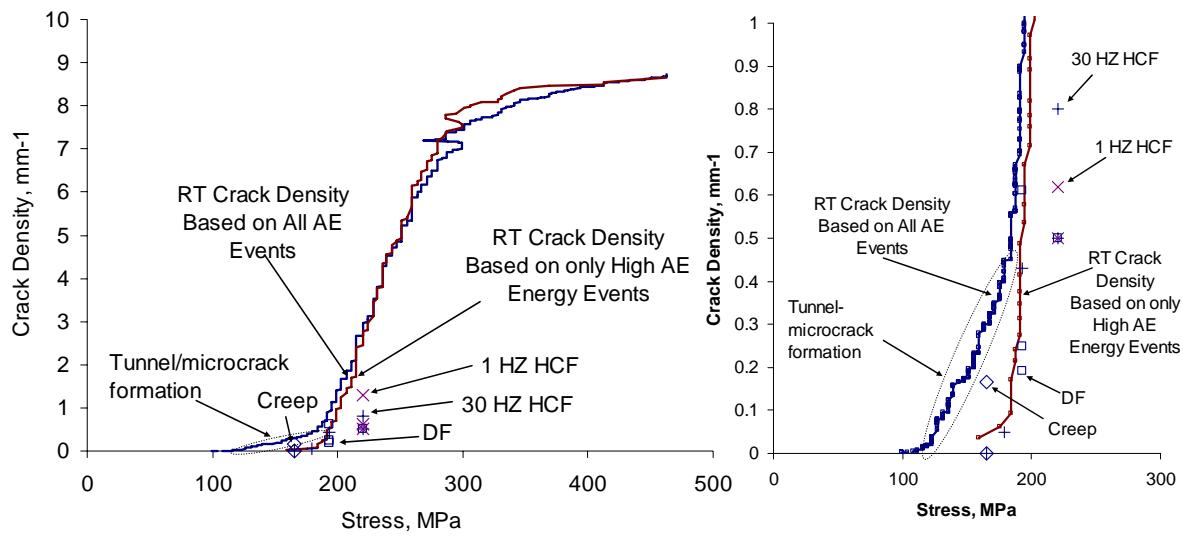
Figure 10: Matrix crack density versus stress for cracks that propagate at least 1 ply.

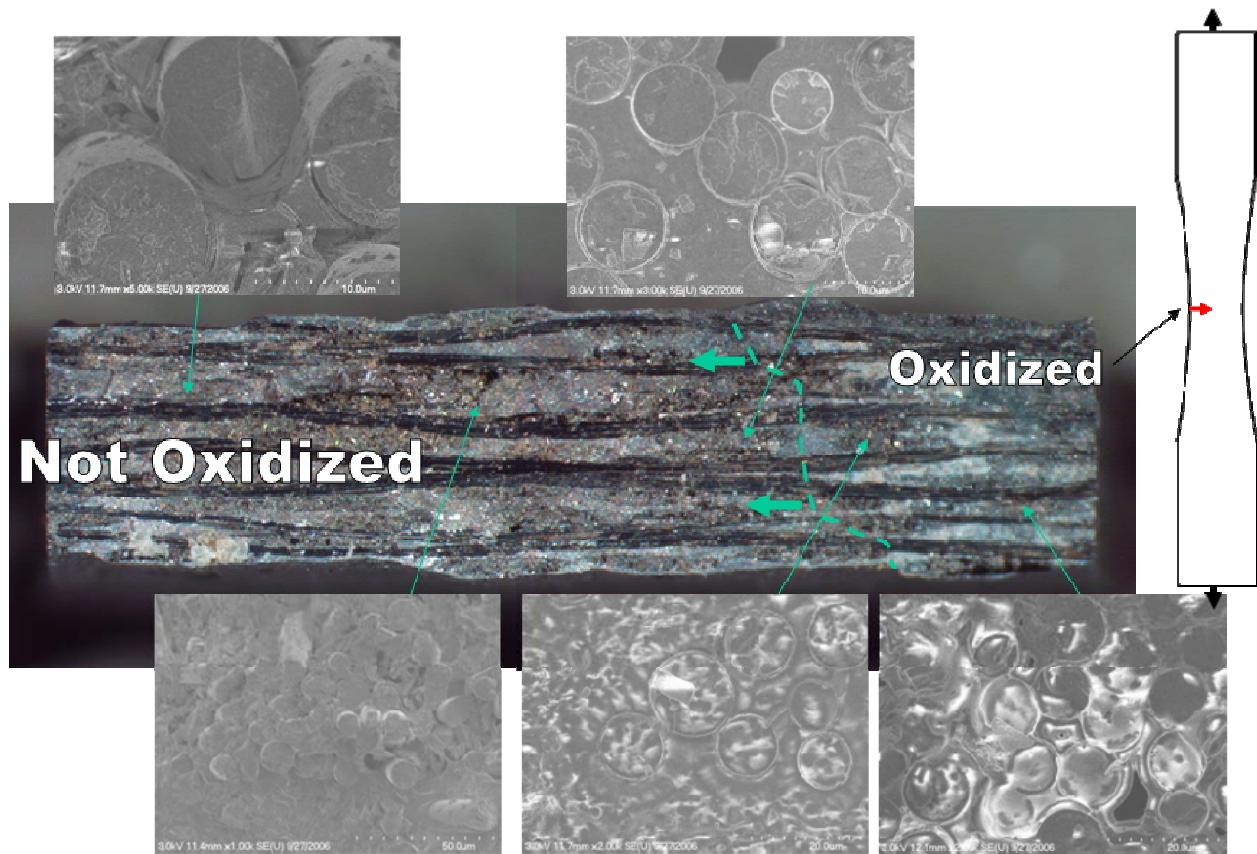
For specimens subjected to stresses of 179 MPa and above, the predominant feature on the fracture surface was a large unbridged crack. In other words, regions of the fracture surface were oxidized including fiber fracture surfaces, BN region, and matrix surface as observed from the polished sections. The rest of the fracture surface was not oxidized, i.e., the SiC matrix surface, fiber fracture surface, and BN interphase were all not oxidized and fiber pullout was prevalent. At these stresses, unbridged cracks typically propagated from the edge of the cross-section (Figure 11) or from the face of the cross-section (Figure 12) always appearing to emanate from or at least include one corner of the specimen cross-section.

Figure 11: Typical unbridged edge-crack growth in specimen tested at 30 hz fatigue, 179 MPa for  $8.1 \times 10^6$  cycles (~ 75 hrs).

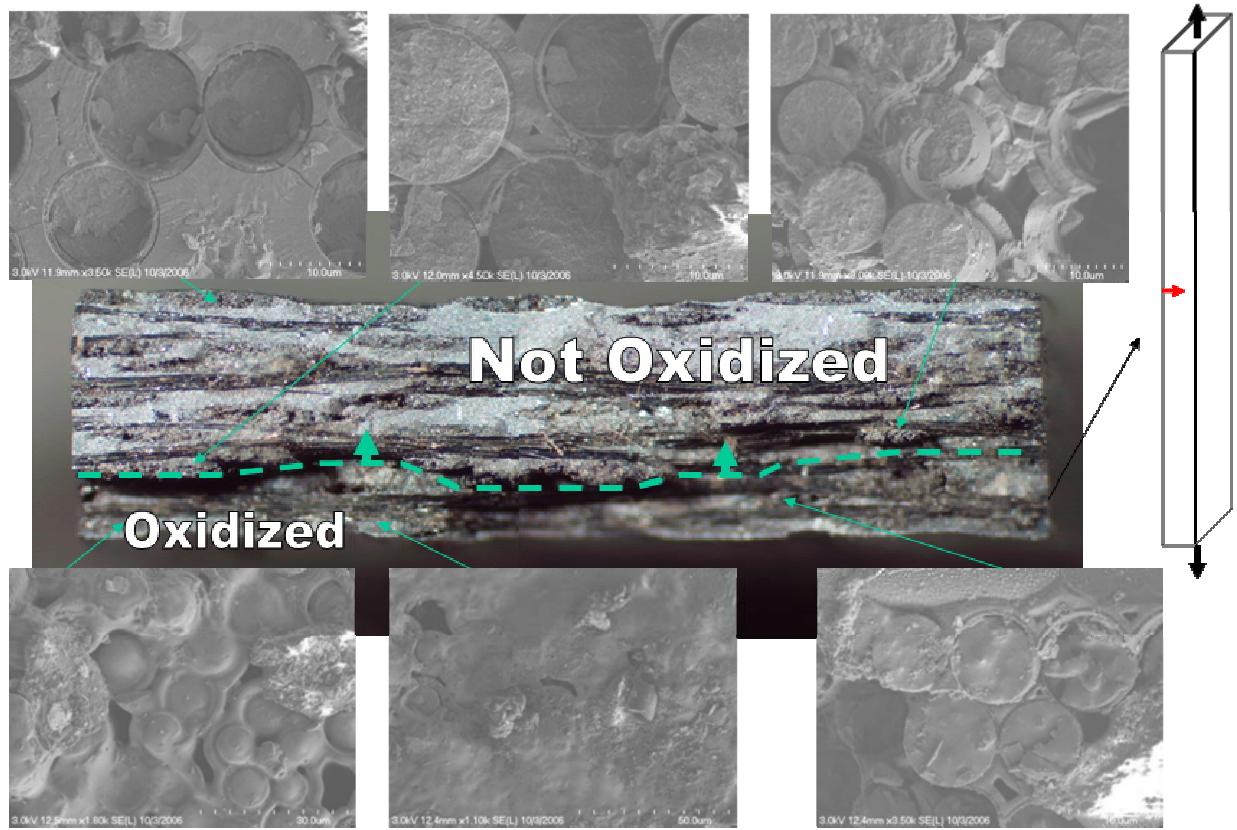
Figure 12: Less typical unbridged face-crack growth in specimen tested at 30 hz fatigue, 220 MPa for 178,493 cycles (~ 1.6 hrs).

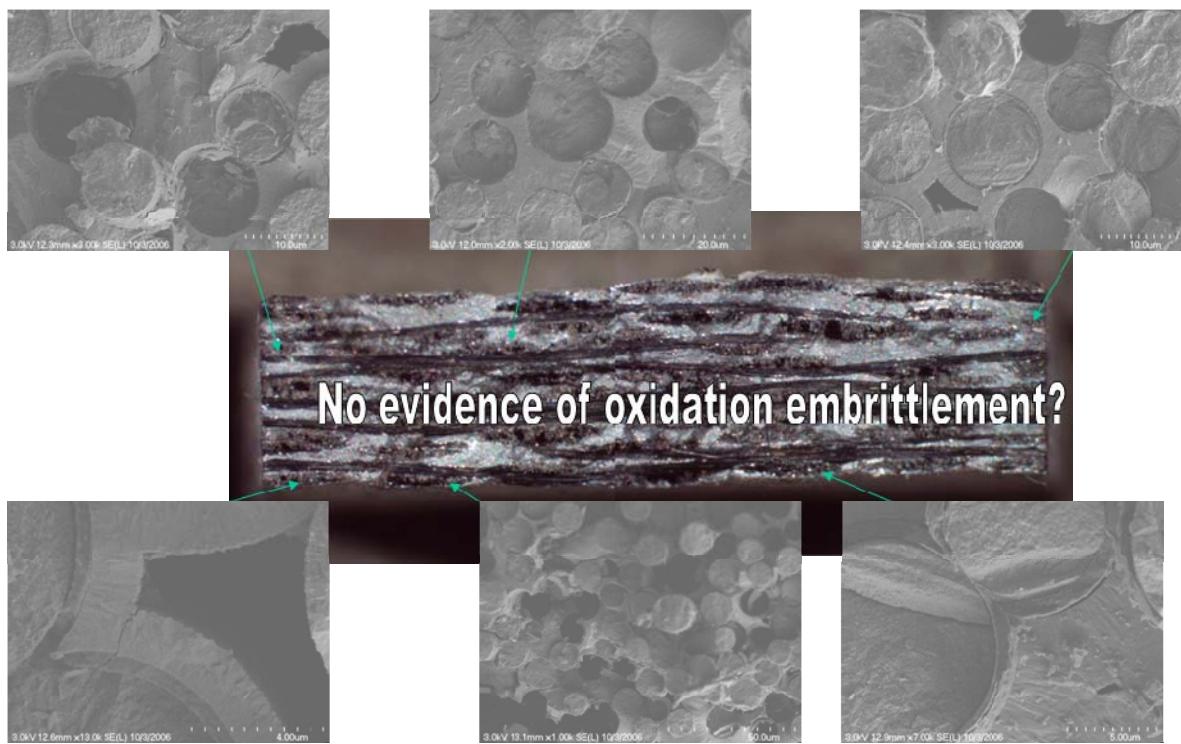
The fracture surfaces of specimens subjected to stresses at 110 and 165 MPa either had a very small region of oxidation on the fracture surface or no real evidence of oxidation-induced embrittlement on the fracture surface. For two specimens that ruptured during creep, a triangular-shaped oxidized region of the fracture surface emanated from one corner of the fracture surface about two plies deep at the edge (the deepest part) and about 5 mm long along the width of the cross-section for the 165 MPa creep specimen which failed at 478 hours and about 2 mm long along the width of the cross-section for the 110 MPa specimen which failed at 1953 hours. Three specimens did not fail at temperature and were subsequently tested at room temperature showed no evidence of oxidation at the fracture surface: a 165 MPa 30 Hz HCF specimen that survived 42,000,000 cycles, a 110 MPa creep specimen that survived 2036 hrs (Figure 13), and a 110 MPa creep specimen that survived 1269 hours.

Figure 13: Fracture surface of 1300-01-006-p02, 110 MPa creep for 2036 hours followed by room temperature residual strength test, showing no oxidation at the fracture surface. The higher magnification images show no oxidation which is best seen by the presence of the BN layer around the fibers and no oxidation of SiC matrix.

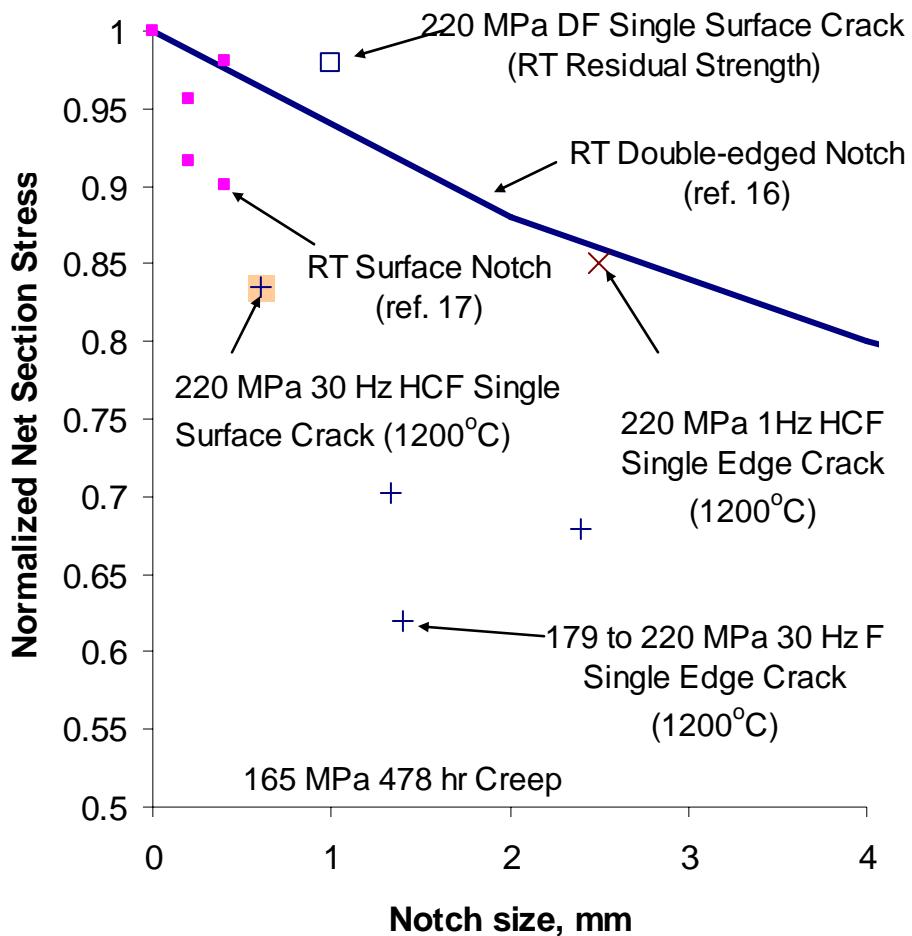
where  $\sigma_{ult}(T)$  is the fast-fracture strength of the composite. Since the times to failure for composites which exhibited significant unbridged cracks was relatively short ( $< 100$  hours),  $\sigma_{ult}(T)$  of the as-produced composites was used at the temperature where the composite was failed. For specimens that failed due to creep or fatigue at temperature,  $\sigma_{ult}(1200^{\circ}\text{C}) = 377 \text{ MPa}$  was used. For specimens that did not fail during creep or fatigue and were then tested at room temperature,  $\sigma_{ult}(\text{RT}) = 450 \text{ MPa}$  was used. Figure 14 shows the Normalized NSS data for some the crept and fatigued specimens of this study and compared to edge-notched [16] and face-notched data [17] for the similar MI composites. For the limited data shown here, the specimens tested under constant load (creep), DF, or 1 hz fatigue appear to follow the room temperature mild notch-sensitivity trend. However, the HCF specimens appear to be more sensitive to the size of the unbridged matrix crack.

Figure 14: Normalized net section stress versus the notch or unbridged crack size.

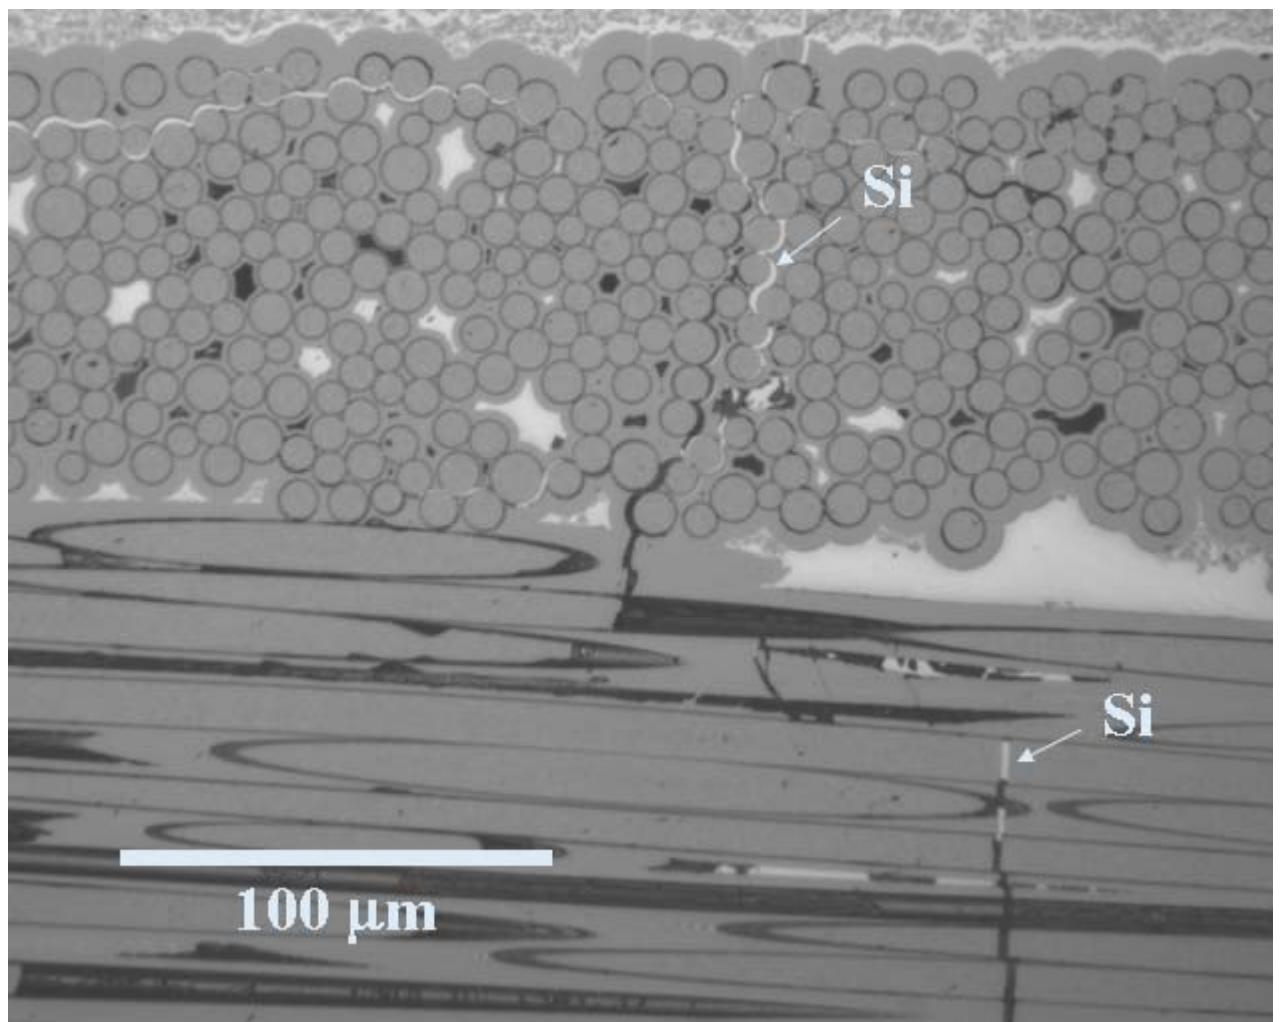
At lower applied stresses, degradation in composite strength was due to a fiber-degradation mechanism not caused by oxidation. For example, the fact that the room temperature ultimate residual strength of the 110 MPa 2036 hour specimens was only slightly greater than one half the strength of the as-produced strength with no evidence for an oxidation-induced cause for failure indicates fiber degradation. Two potential mechanisms for this behavior can be considered for this type of a mechanism. Most likely, fiber degradation is due to an intrinsic creep-controlled flaw growth mechanism. Creep rupture of SiC fibers has been well documented the cause of which linked to diffusional creep mechanisms [18]. However, another possibility would be due to diffusion of free Si from the composite matrix which has been observed to attack fibers and degrade composites with no stress above  $1350^{\circ}\text{C}$  [19]. This seems more unlikely because no such mechanism has been observed at temperatures lower than or equal to  $1300^{\circ}\text{C}$  for the times considered here, although stress may enhance diffusion of free Si and lead to a similar effect. For example, Figure 15 shows evidence of Si diffusion into some regions of  $90^{\circ}$  minicomposite microcracks and the unbridged region of a  $0^{\circ}$  minicomposite crack for a specimen that ruptured after 1500 hours at 165 MPa creep.

Figure 15: Micrograph of 165 MPa creep specimen that failed after 1500 hours that shows the presence of some free Si in the 90° and 0° minicomposite portions of an unbridged crack well away from the fracture surface.
